MidAmerica St. Louis Airport Runway 14L/32R

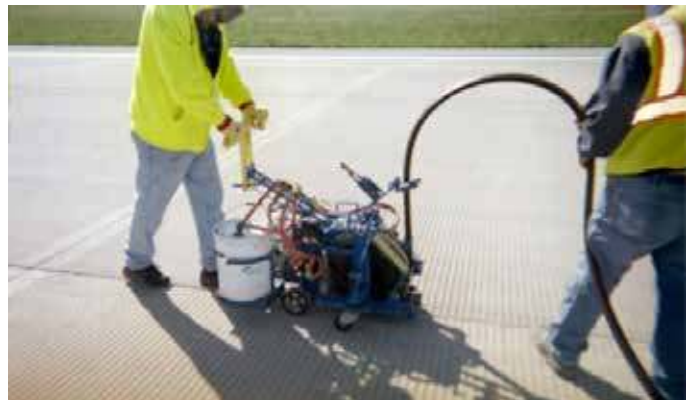
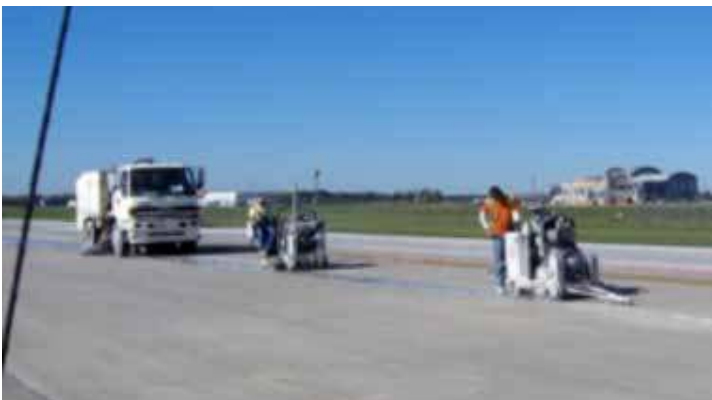
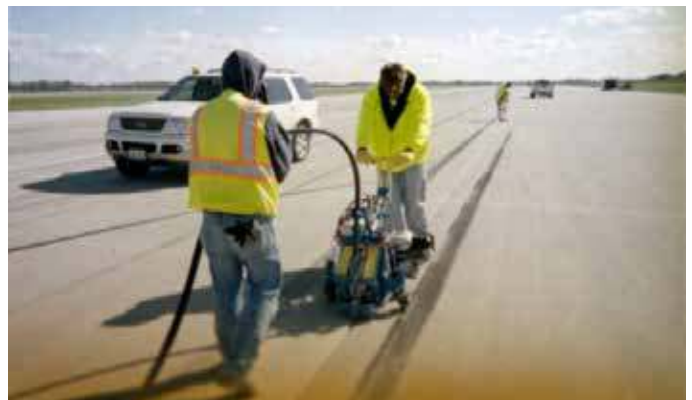
Over time, the silicone joint sealants began to fail and the airport was spending an ever-increasing amount of resources to continually replace portions of the joint sealant. Recognizing that the expected life of the silicone joint sealant is only 8 to 10 years, the airport looked to a longer term solution when replacing these sealants on the runway and taxiway. The compression sealants installed at the same time on the transverse joints were still in good condition so the decision was made to replace all of the silicone sealants with compression sealants.

The work began in October 2009 with an expected completion time of 35 calendar days. The joint repair included removing the existing joint sealant by sawing and widening the existing joint, sandblasting to clean the joint, and sealing the joint with a preformed compression joint sealant. The existing joints varied from 3/8 to 1/2 inch and were sawed to a new width of 3/4 inch. The new 3/4 inch joint width eliminated any joint width irregularities and allowed for the easy installation of the new compression sealant.
