# MidAmerica St. Louis Airport- Runway 14L/32R

## Case Study

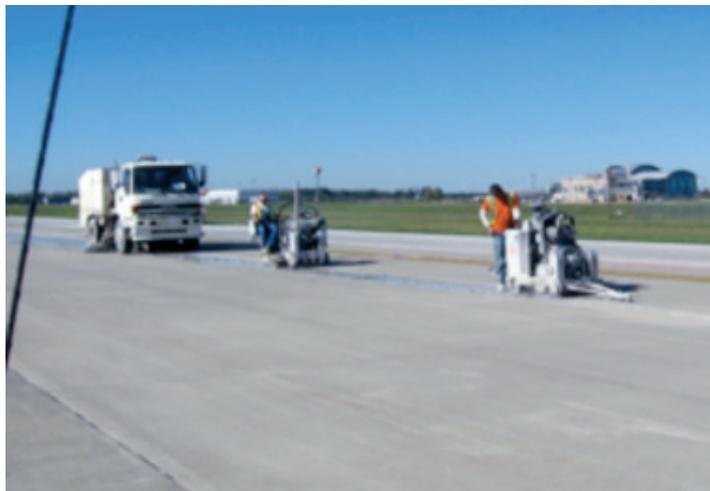
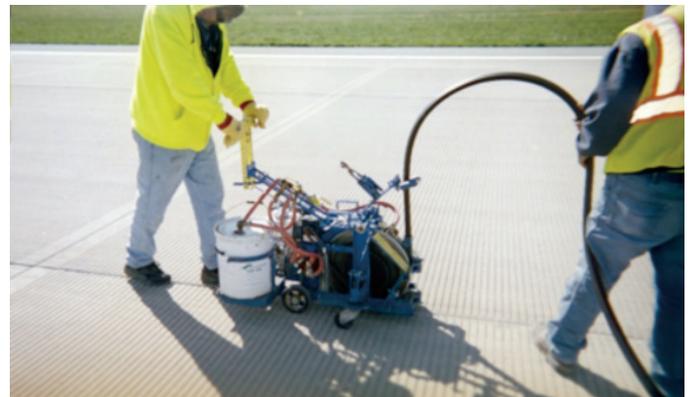
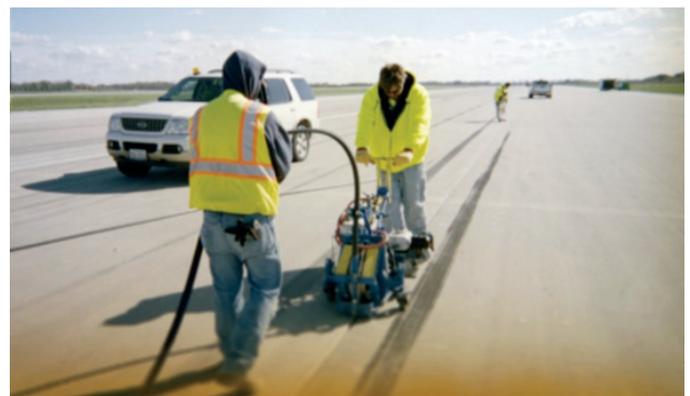
The work began in October 2009 with an expected completion time of 35 calendar days. The joint repair included removing the existing joint sealant by sawing and widening the existing joint, sandblasting to clean the joint, and sealing the joint with a preformed compression joint sealant. The existing joints varied from 3/8 to 1/2 inch and were sawed to a new width of 3/4 inch. The new 3/4 inch joint width eliminated any joint width irregularities and allowed for the easy installation of the new compression sealant.
