## MidAmerica St. Louis Airport Runway 14L/32R

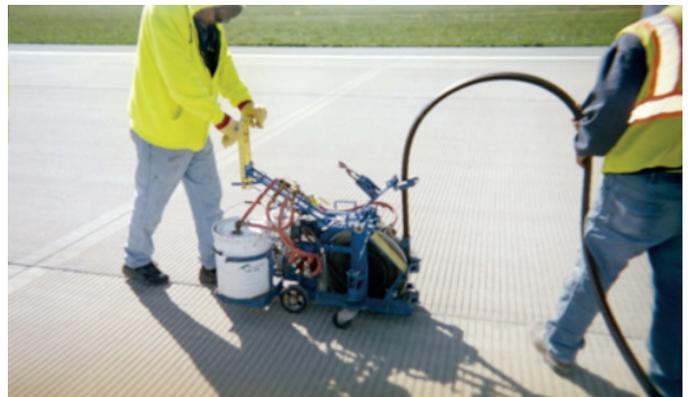
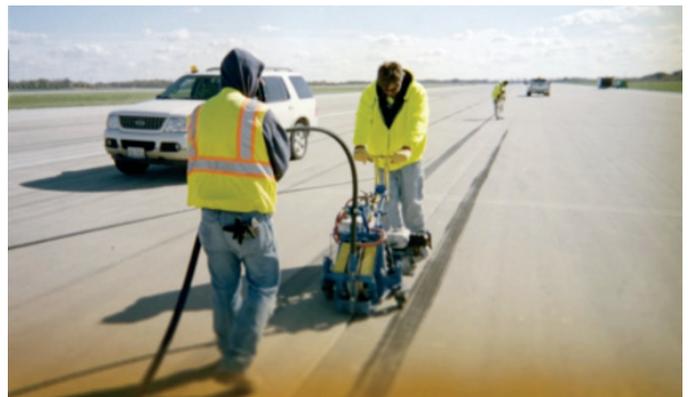
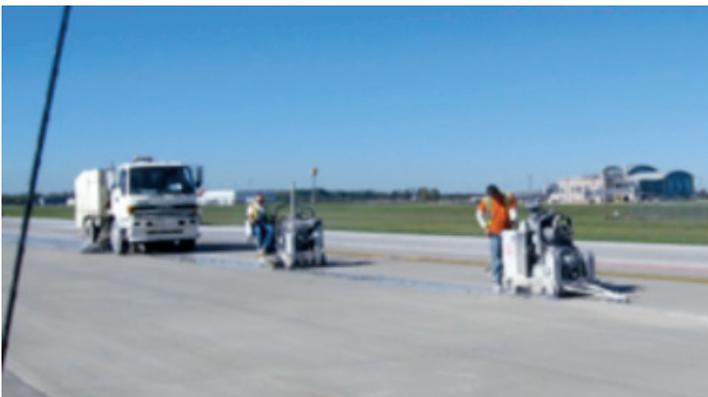
The work began in October 2009 with an expected completion time of 35 calendar days. The joint repair included removing the existing joint sealant by sawing and widening the existing joint, sandblasting to clean the joint, and sealing the joint with a preformed compression joint sealant. The existing joints varied from 3/8 to 1/2 inch and were sawed to a new width of 3/4 inch. The new 3/4 inch joint width eliminated any joint width irregularities and allowed for the easy installation of the new compression sealant.
